FISH AND FISH
HABITAT EXISTING
CONDITIONS AND
IMPACT ASSESSMENT
REPORT

DRAFT FISH AND FISH HABITAT IMPACT ASSESSMENT REPORT

HIGHWAY 417 BRIDGE REHABILITATIONS
CONTRACT 2B (GWP 4074-11-00)

PROJECT NO.: 17M-00850-01
DATE: FEBRUARY 2022

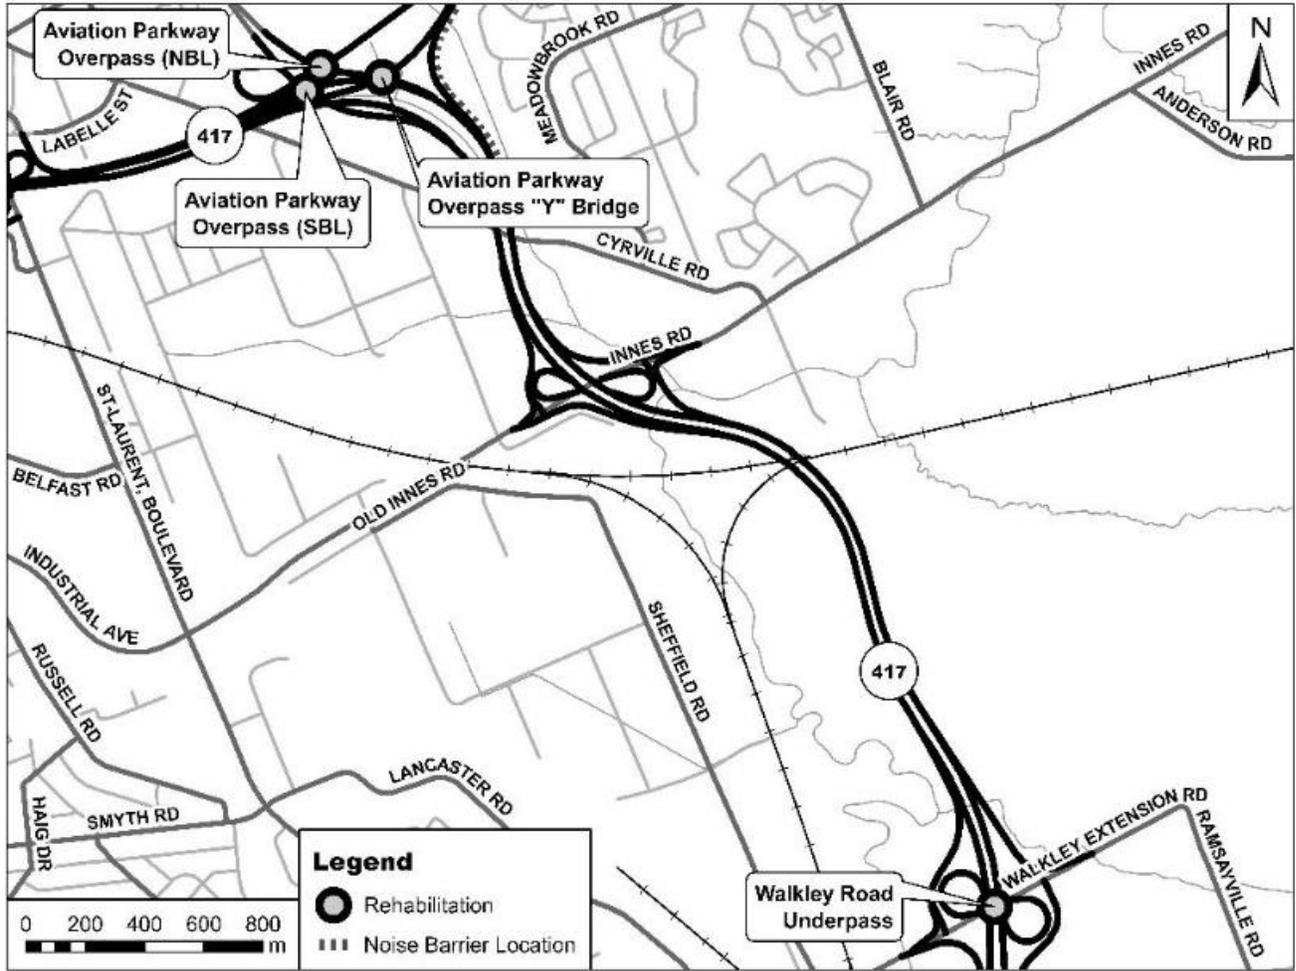
Figure 1-1: Key Site Plan for Highway 417 Bridges at Aviation Parkway and Walkley Road

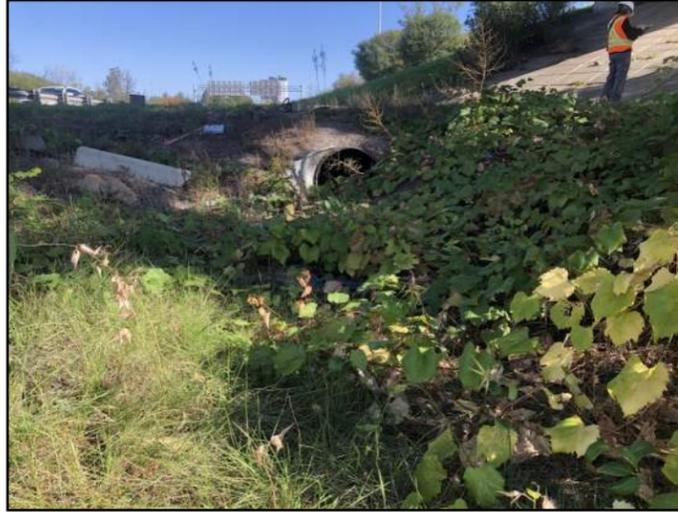
Photo 1: Culvert under Aviation Parkway NB bridge, south of OR174 WB lanes, culvert inlet, facing east. Date October 20th, 2021.

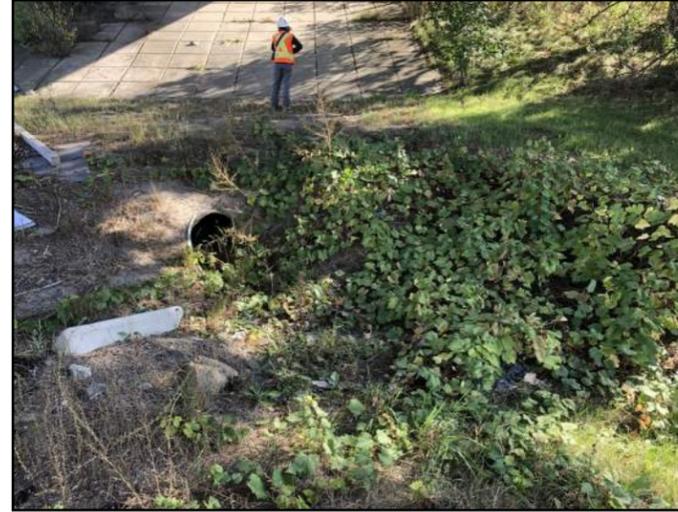
Photo 2: Culvert under Aviation Parkway NB bridge, south of OR174 WB lanes, culvert inlet, facing southeast. Date October 20th, 2021.

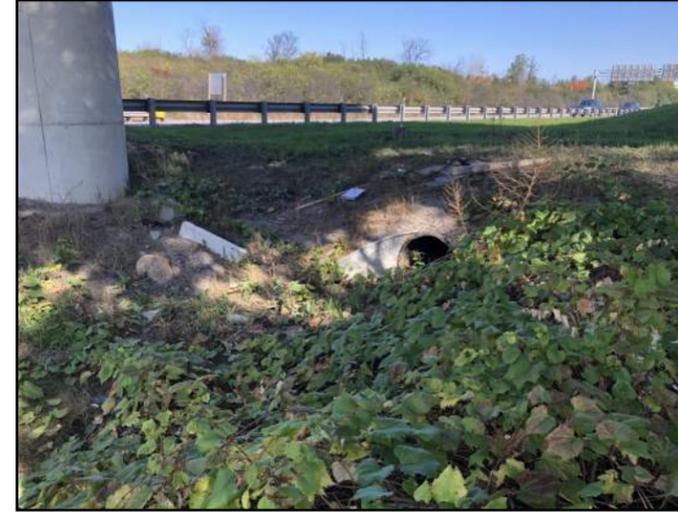
Photo 3: Culvert under Aviation Parkway NB bridge, south of OR174 WB lanes, culvert inlet, facing northeast. Date October 20th, 2021.

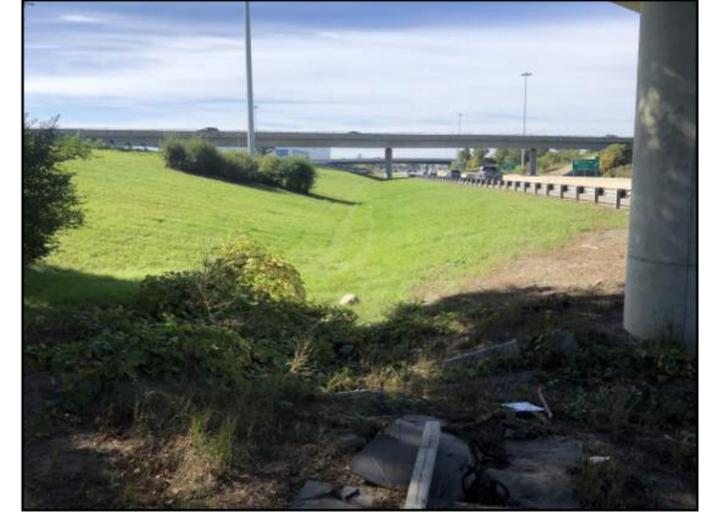
Photo 4: Culvert under Aviation Parkway NB bridge, south of OR174 WB lanes, culvert inlet, facing west. Date: October 20th, 2021.

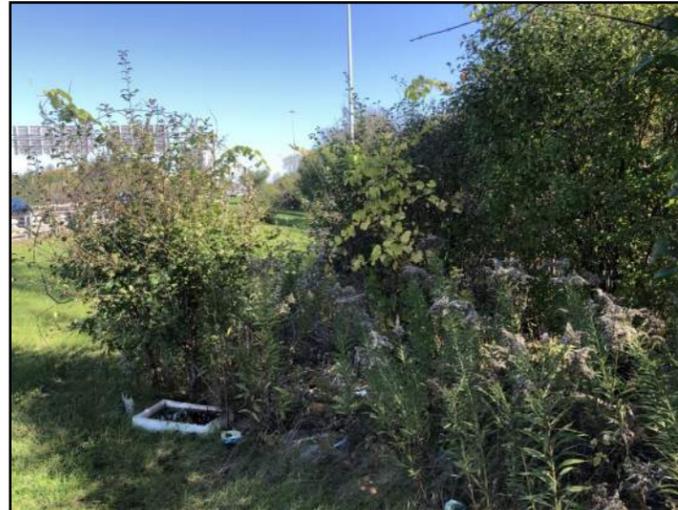
Photo 5: Culvert under Aviation Parkway NB bridge, south of OR174 WB lanes, culvert outlet, facing east. Date October 20th, 2021.

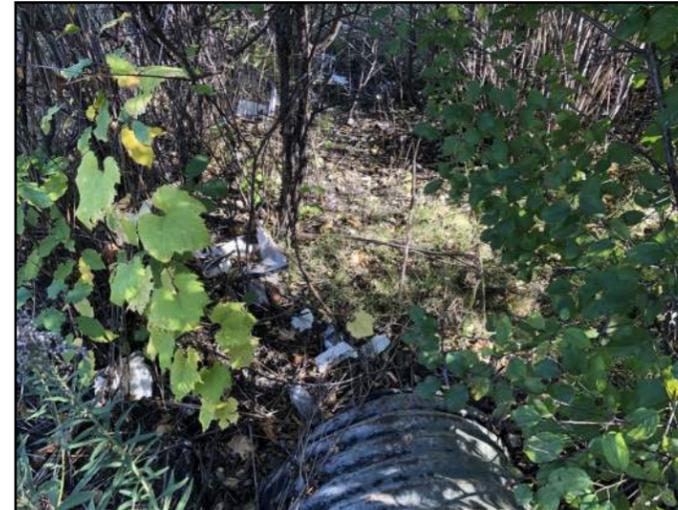
Photo 6: Culvert under Aviation Parkway NB bridge, south of OR174 WB lanes, culvert outlet, facing east. Date October 20th, 2021.

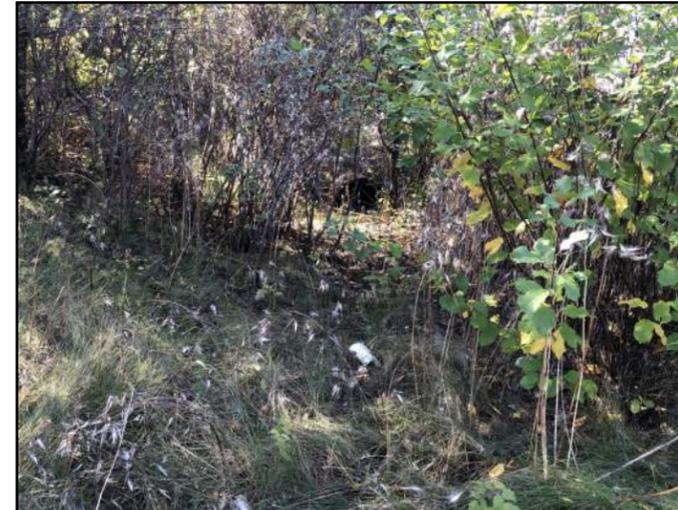
Photo 7: Culvert under Aviation Parkway NB bridge, south of OR174 WB lanes, culvert outlet, facing west. Date October 20th, 2021.

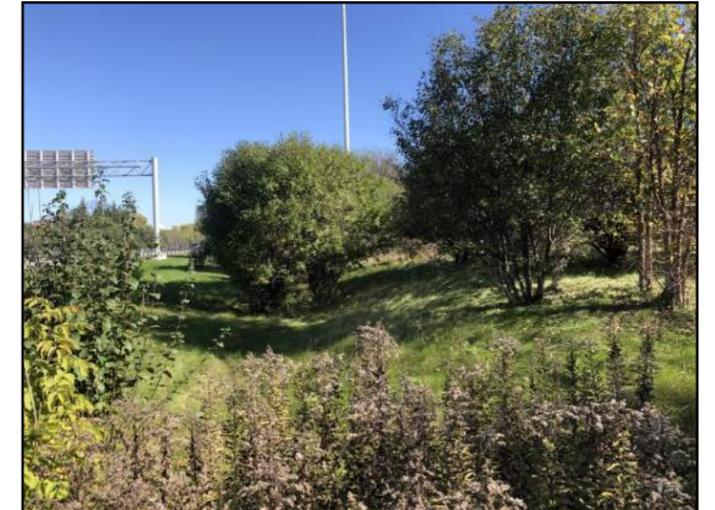
Photo 8: Culvert under Aviation Parkway NB bridge, south of OR174 WB lanes, culvert outlet, facing east. Date October 20th, 2021.

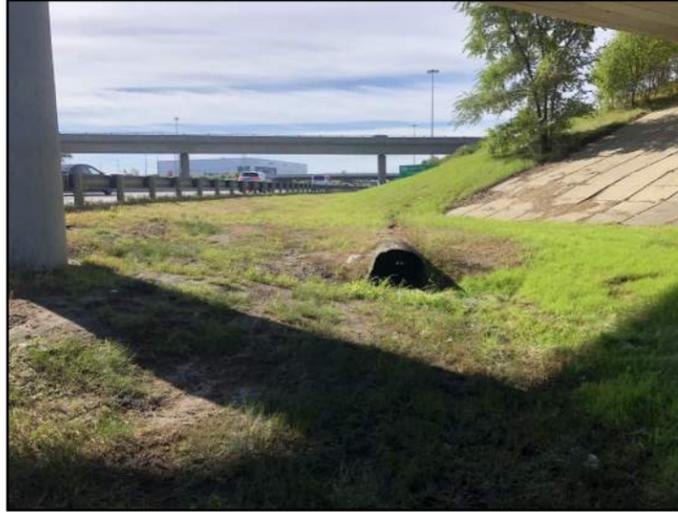
Photo 9: Culvert under Aviation Parkway NB bridge, north of OR174 WB lanes, culvert outlet, facing west. Date October 20th, 2021.

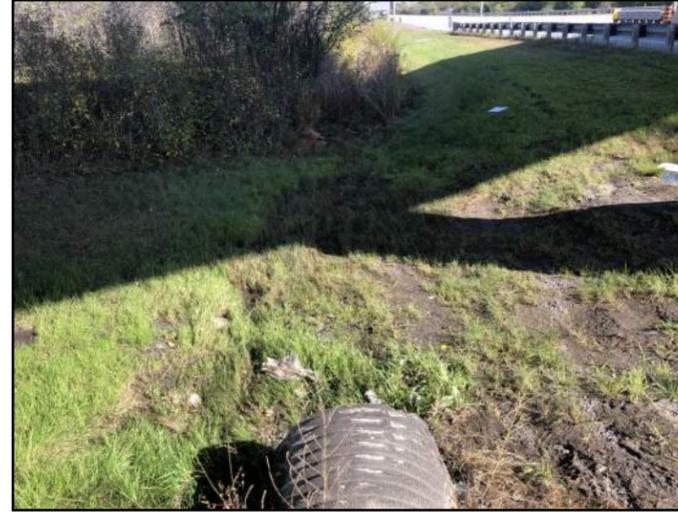
Photo 10: Culvert under Aviation Parkway NB bridge, north of OR174 WB lanes, culvert outlet, facing east. Date October 20th, 2021.

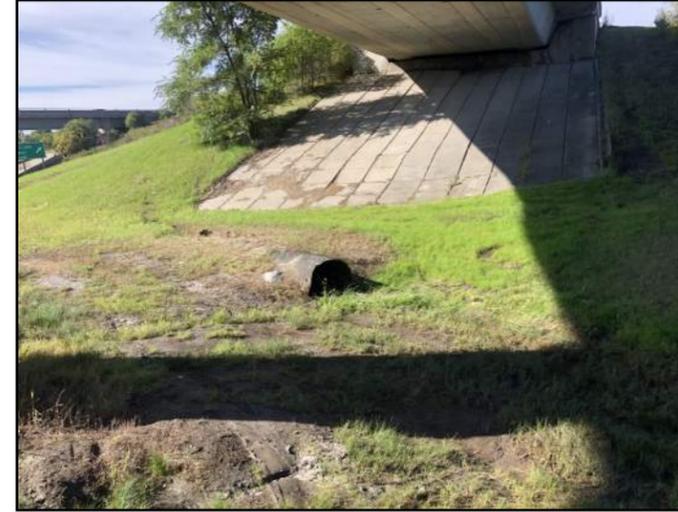
Photo 11: Culvert under Aviation Parkway NB bridge, north of OR174 WB lanes, culvert outlet, facing northwest. Date October 20th, 2021.

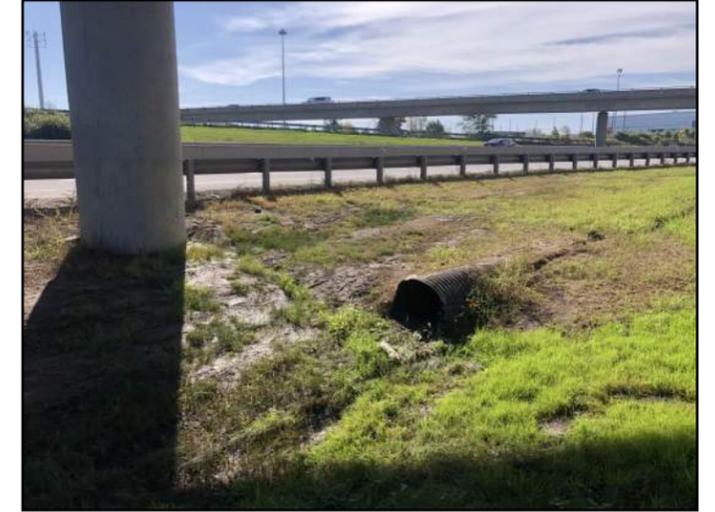
Photo 12: Culvert under Aviation Parkway NB bridge, north of OR174 WB lanes, culvert outlet, facing southwest. Date October 20th, 2021.

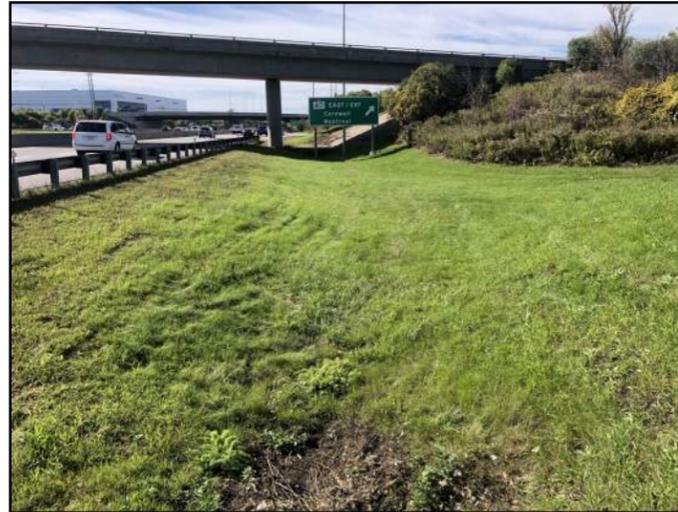
Photo 13: Culvert under Aviation Parkway NB bridge, north of OR174 WB lanes, culvert inlet, facing west. Date October 20th, 2021.

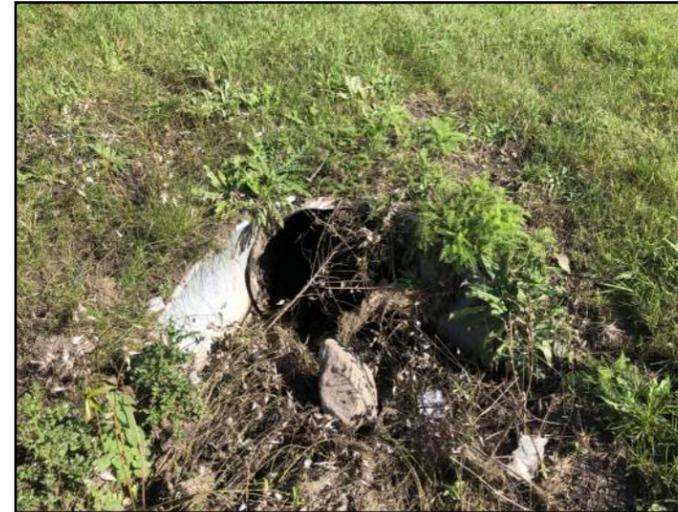
Photo 14: Culvert under Aviation Parkway NB bridge, north of OR174 WB lanes, culvert inlet, facing east. Date October 20th, 2021.

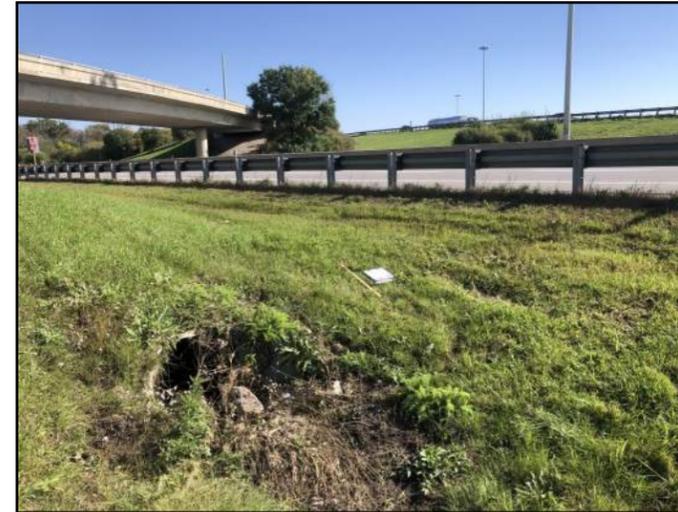
Photo 15: Culvert under Aviation Parkway NB bridge, north of OR174 WB lanes, culvert inlet, facing southeast. Date October 20th, 2021.

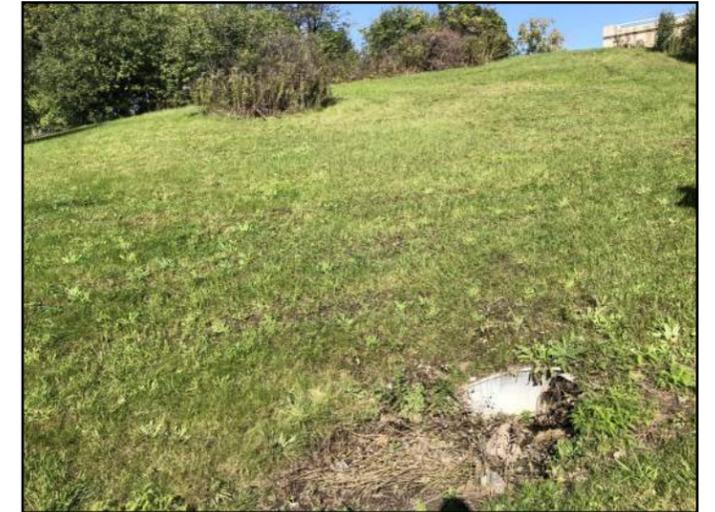
Photo 16: Culvert under Aviation Parkway NB bridge, north of OR174 WB lanes, culvert inlet, facing northeast. Date October 20th, 2021.

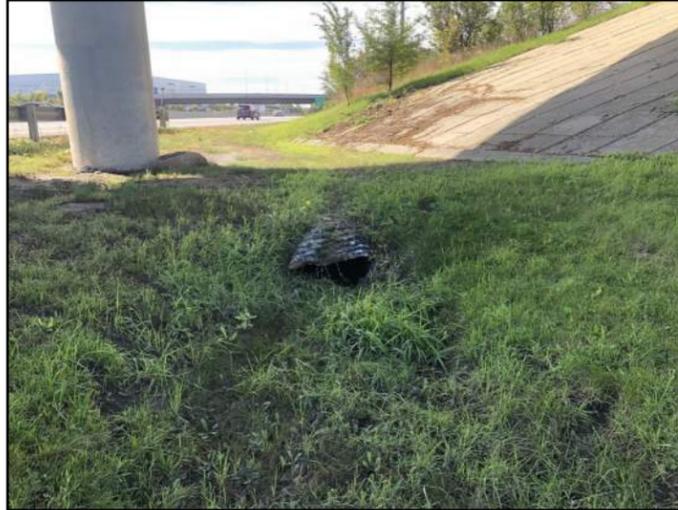
Photo 17: Culvert under Aviation Parkway SB bridge, north of OR174 WB lanes, culvert outlet, facing west. Date October 20th, 2021.

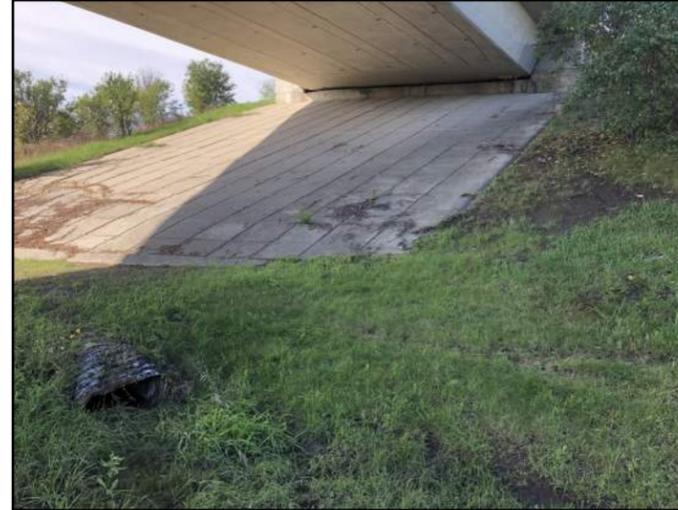
Photo 18: Culvert under Aviation Parkway SB bridge, north of OR174 WB lanes, culvert outlet, facing northwest. Date October 20th, 2021.

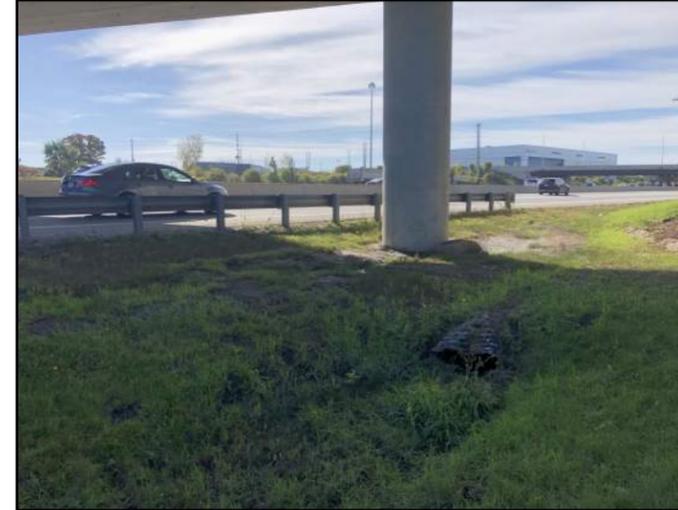
Photo 19: Culvert under Aviation Parkway SB bridge, north of OR174 WB lanes, culvert outlet, facing southwest. Date October 20th, 2021.

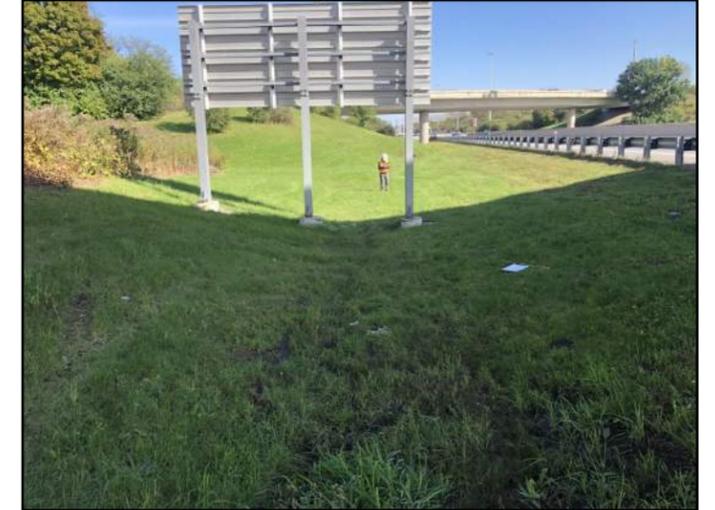
Photo 20: Culvert under Aviation Parkway SB bridge, north of OR174 WB lanes, culvert outlet, facing east. Date October 20th, 2021.

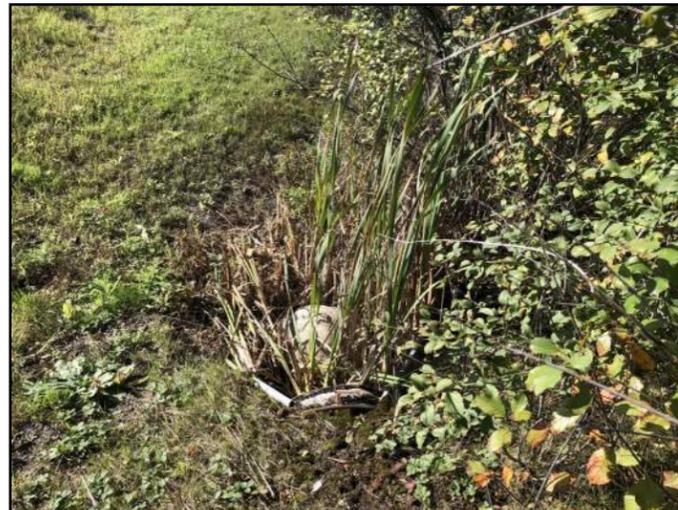
Photo 21: Culvert under Aviation Parkway SB bridge, north of OR174 WB lanes, culvert inlet. Date October 20th, 2021.

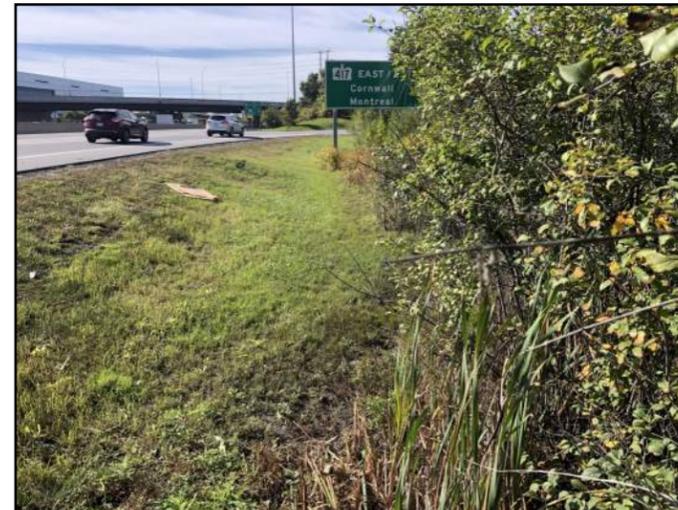
Photo 22: Culvert under Aviation Parkway SB bridge, north of OR174 WB lanes, culvert inlet, facing west. Date October 20th, 2021.

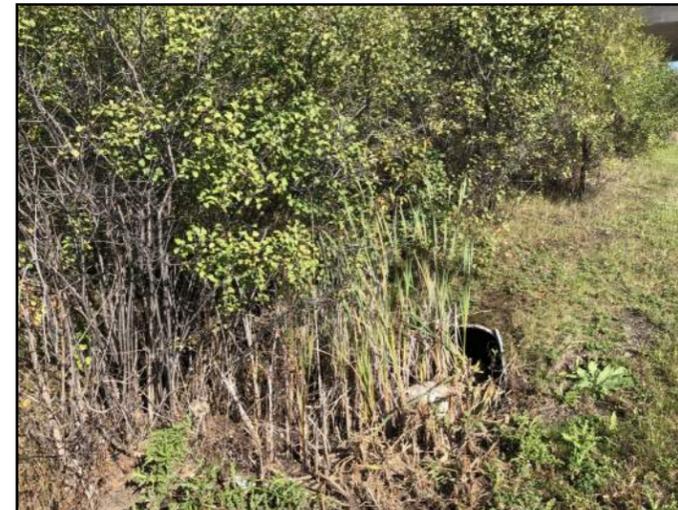
Photo 23: Culvert under Aviation Parkway SB bridge, north of OR174 WB lanes, culvert inlet, facing northeast. Date October 20th, 2021.

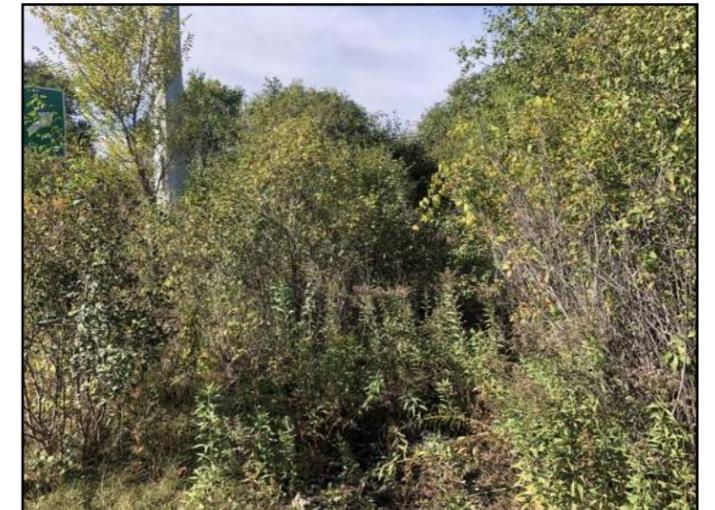
Photo 24: Culvert under Aviation Parkway SB bridge, north of OR174 WB lanes, culvert inlet, facing north. Date October 20th, 2021.

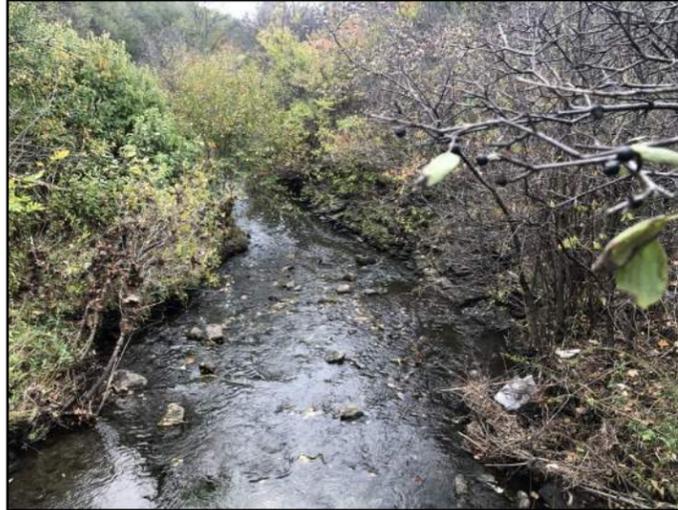
Photo 25: 7-735C Cote Martin Drain culvert under OR174 EB on ramp, culvert outlet, facing south. Date October 20th, 2021.

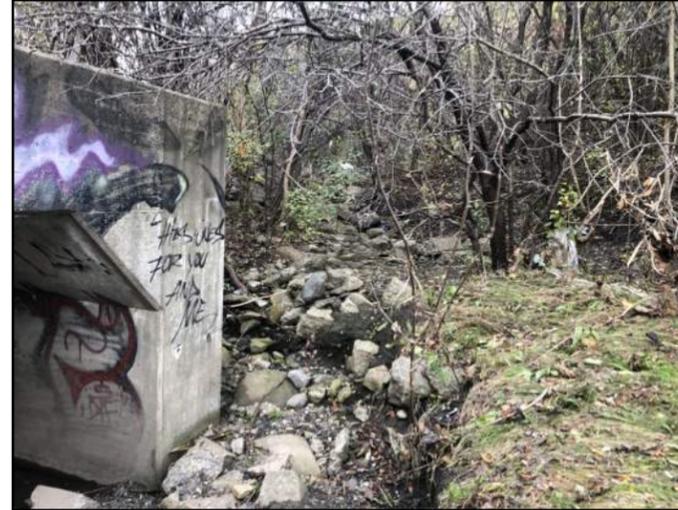
Photo 26: 7-735C Cote Martin Drain culvert under OR174 EB on ramp, culvert outlet, facing east, showing erosion at wall. Date October 20th, 2021.

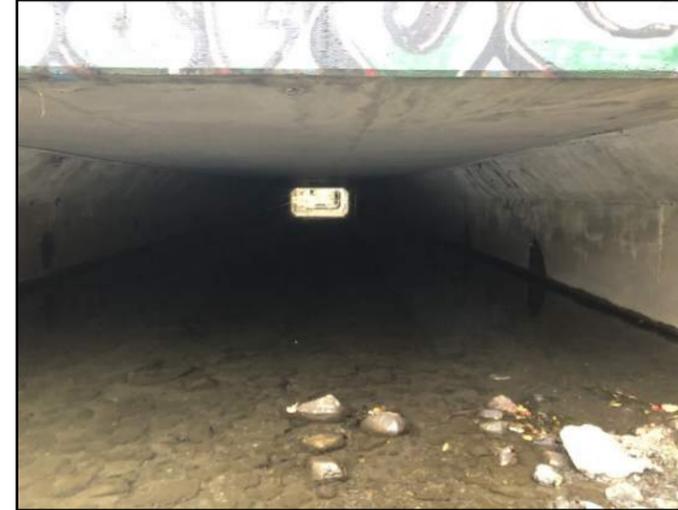
Photo 27: 7-735C Cote Martin Drain culvert under OR174 EB on ramp, culvert outlet, facing upstream inside culvert. Date October 20th, 2021.

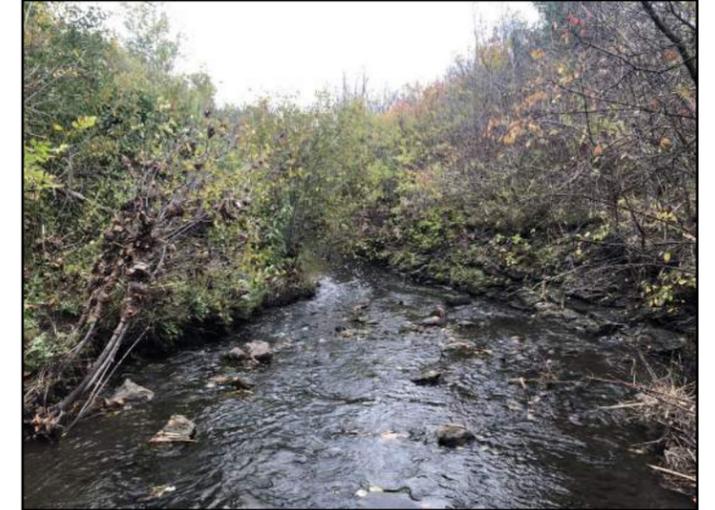
Photo 28: 7-735C Cote Martin Drain culvert under OR174 EB on ramp, riffle habitat downstream of culvert outlet. Date October 20th, 2021.

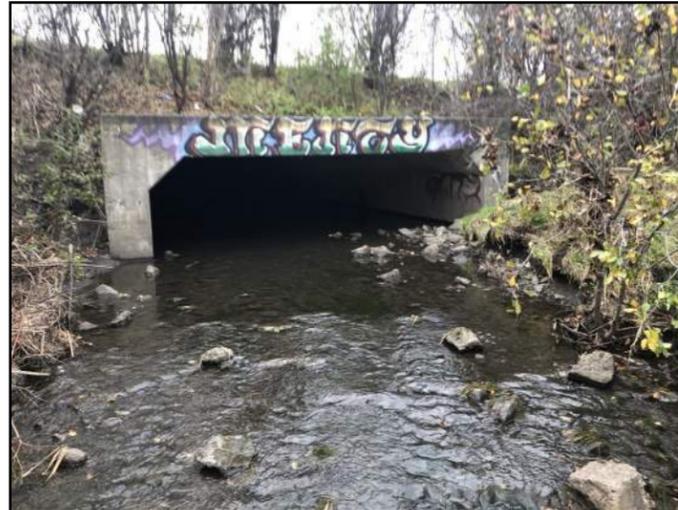
Photo 29: 7-735C Cote Martin Drain culvert under OR174 EB on ramp, culvert outlet, facing upstream showing riffle habitat downstream of outlet. Date October 20th, 2021.

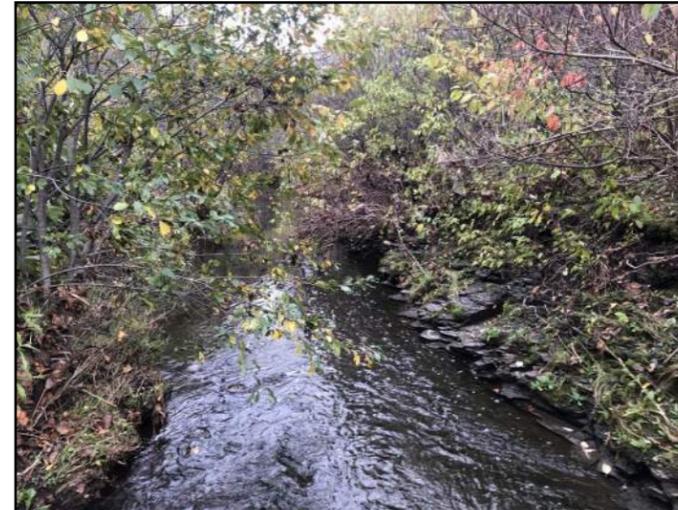
Photo 30: 7-735C Cote Martin Drain culvert under OR174 EB on ramp, run habitat downstream. Date October 20th, 2021.

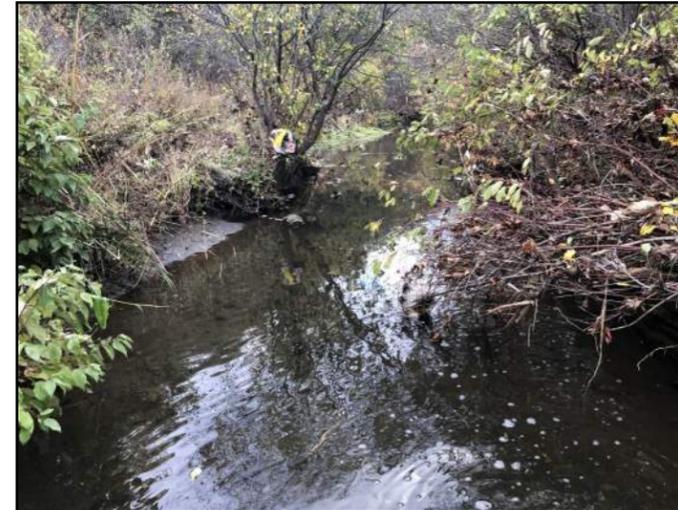
Photo 31: 7-735C Cote Martin Drain culvert under OR174 EB on ramp, run habitat downstream. Date October 20th, 2021.

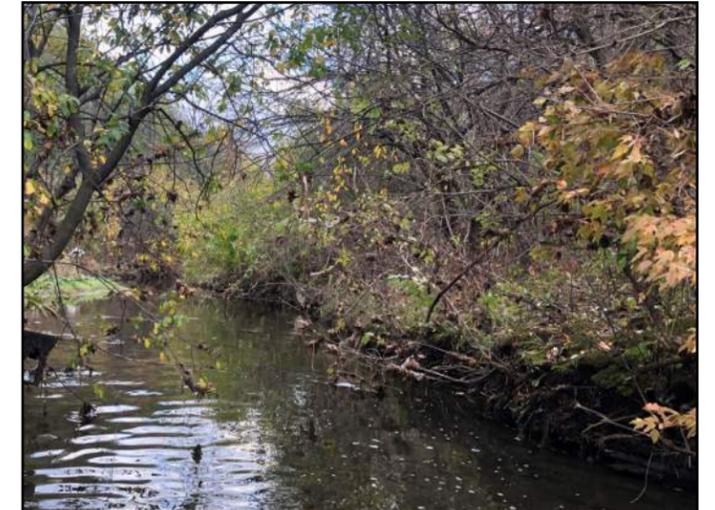
Photo 32: 7-735C Cote Martin Drain culvert under OR174 EB on ramp, run habitat downstream. Date October 20th, 2021.

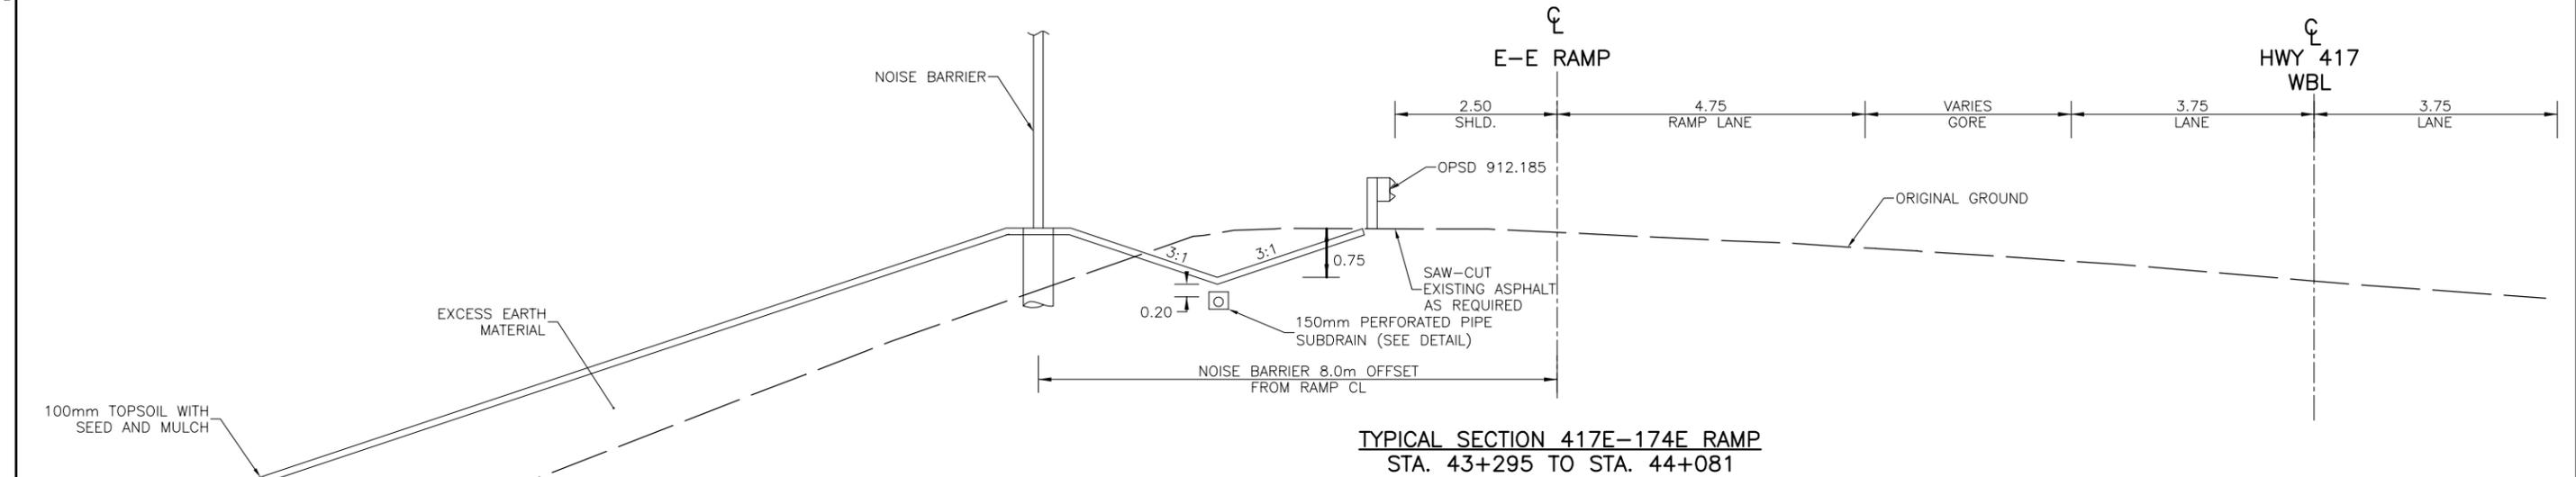
TYPICAL SECTION 417E-174E RAMP
STA. 43+295 TO STA. 44+081

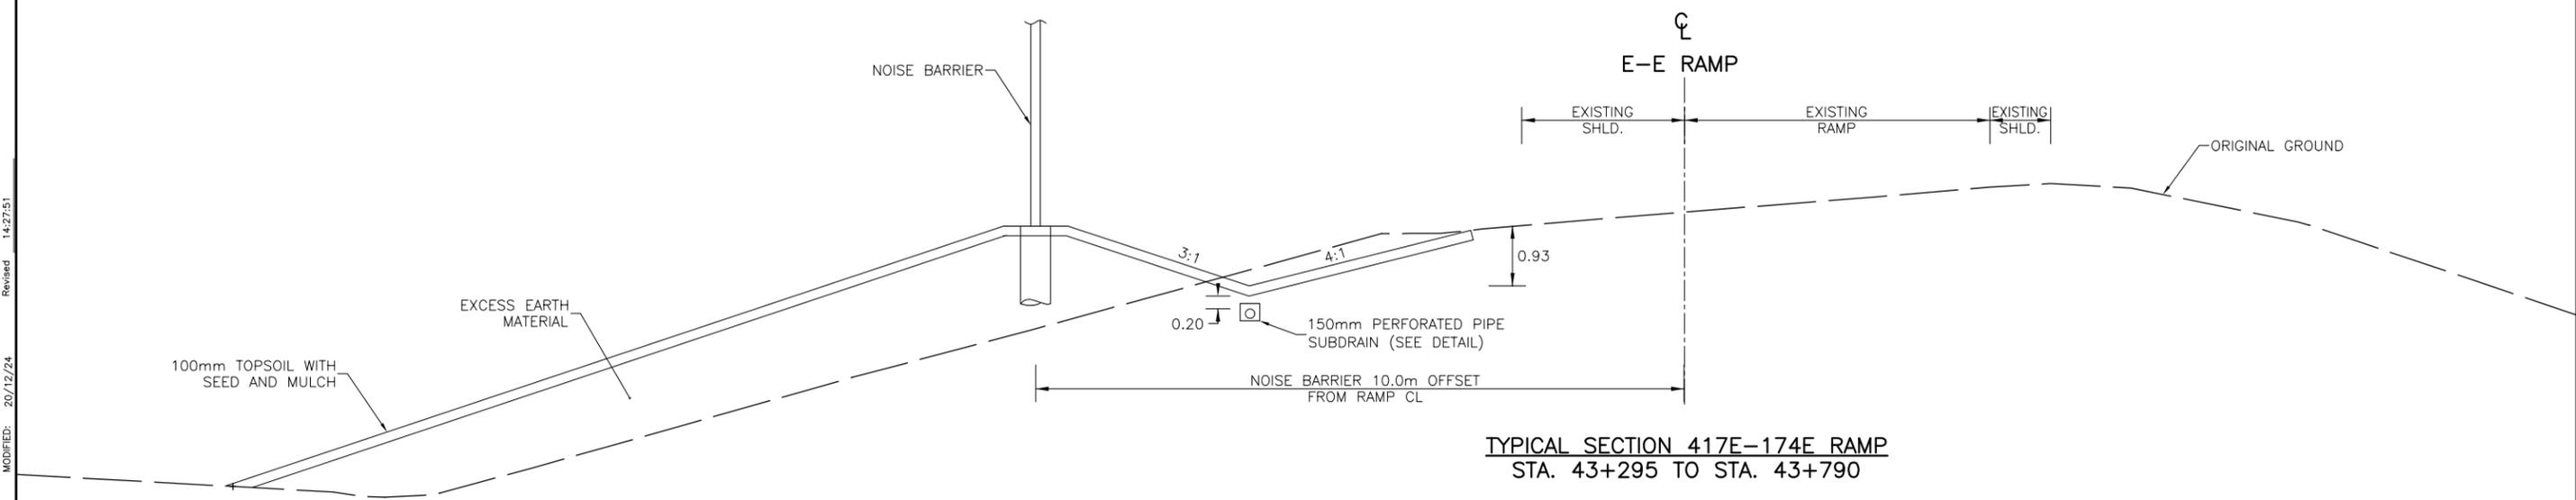
TYPICAL SECTION 417E-174E RAMP
STA. 43+295 TO STA. 43+790
